Re: *Raley v. Hyundai*

This letter provides a summary of our preliminary systems analysis of the 1999 Hyundai Sonata rollover crash that catastrophically injured Misty Raley.

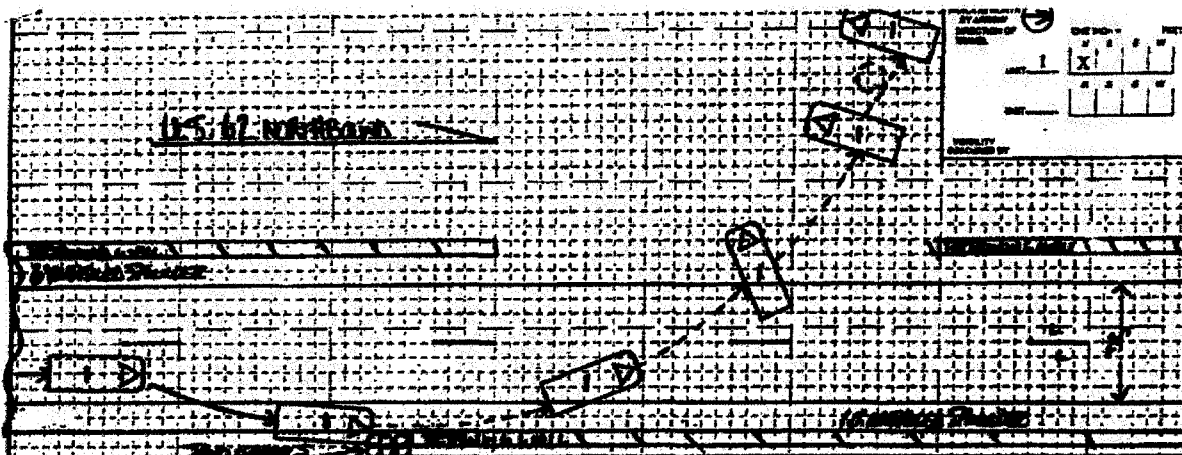
Figure 1: Police Report Accident Diagram

The vehicle veered to the right striking a group of sand barrels before entering a counterclockwise yaw and moving off the roadway to the left. The vehicle slid and rolled down an embankment before coming to rest. The driver was ejected 6' north of the POR of the vehicle. The police report accident diagram is reproduced in Figure 1.

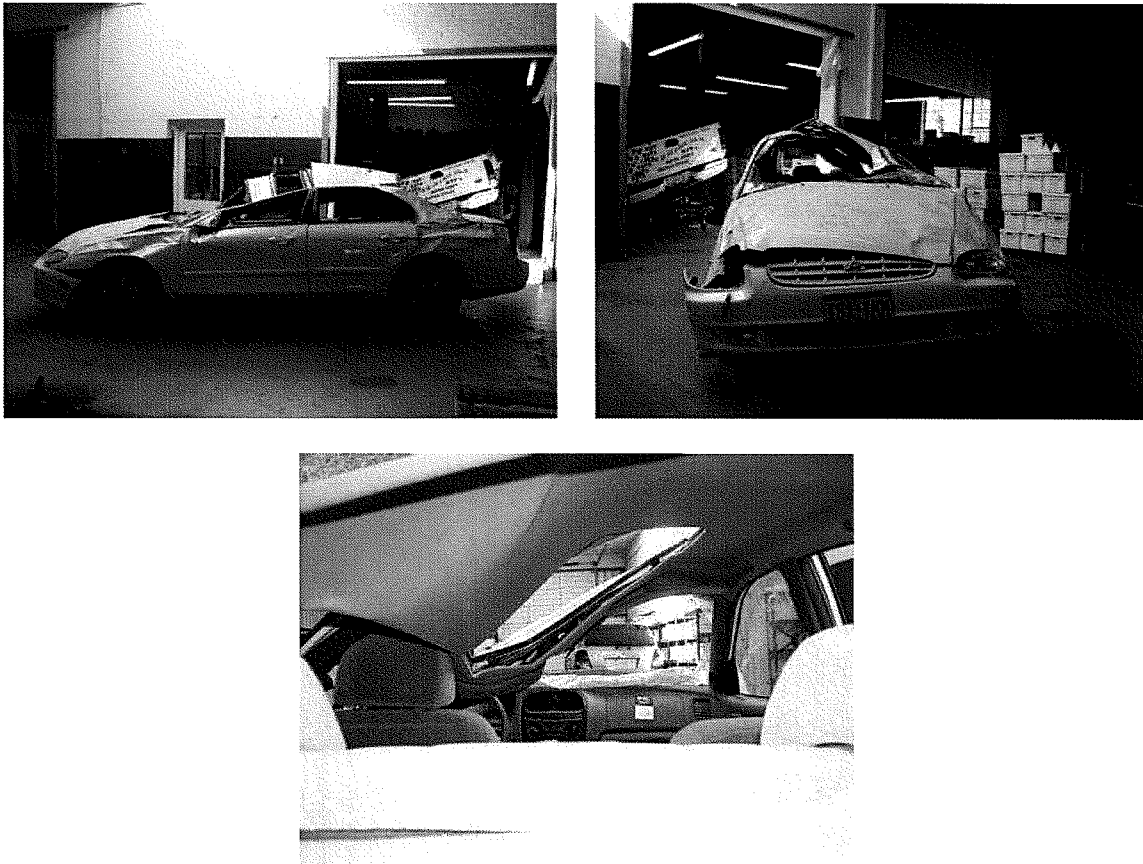
The vehicle, a 1999 Hyundai Sonata, has suffered significant damage consistent with a rollover. There is damage to the entire vehicle both from the initial side swipe contact with the sand barrels and the subsequent rollover. The damage to the roof of the vehicle is concentrated above the driver's seating position, see Figure 2.

Figure 2: Overview pictures of the vehicle showing rollover damage.

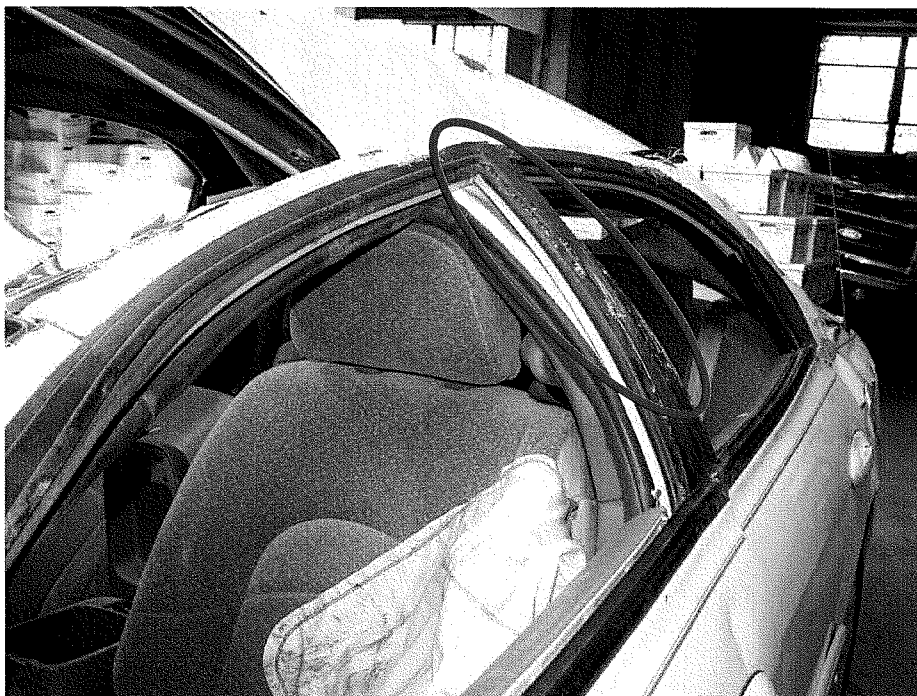
The driver's side front window was up prior to the accident as demonstrated by the glass fragments retained in the window gasket, see Figure 3.

Figure 3: Glass fragments in the window gasket.

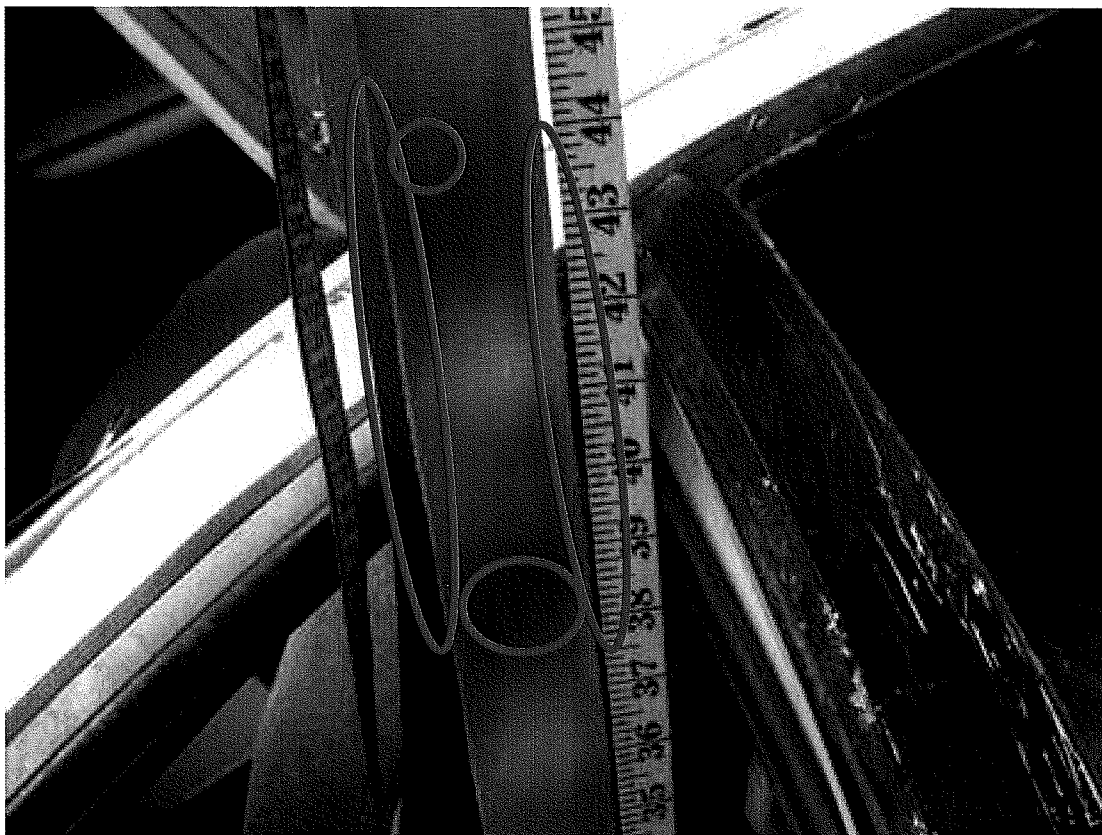
The police report and medical reports indicate that Ms. Raley was unrestrained, but an inspection of the vehicle reveals evidence to suggest that she was wearing her belt. Investigators often assume an ejected occupant was unbelted. Scuff marks can be seen at approximately 38 inches and 44 inches on the driver's belt, as measured from the anchor point, see Figure 4. Numerous torn threads are also visible along the length of the belt. The presence of the scuff marks and torn threads on the belt are consistent with the belt being in use at the time of the accident and released as a result of false latching or inertial unlatching leading to her ejection.

Figure 4: Scuff marks and torn threads on the driver's belt, indicating it was in use at the time of the accident.

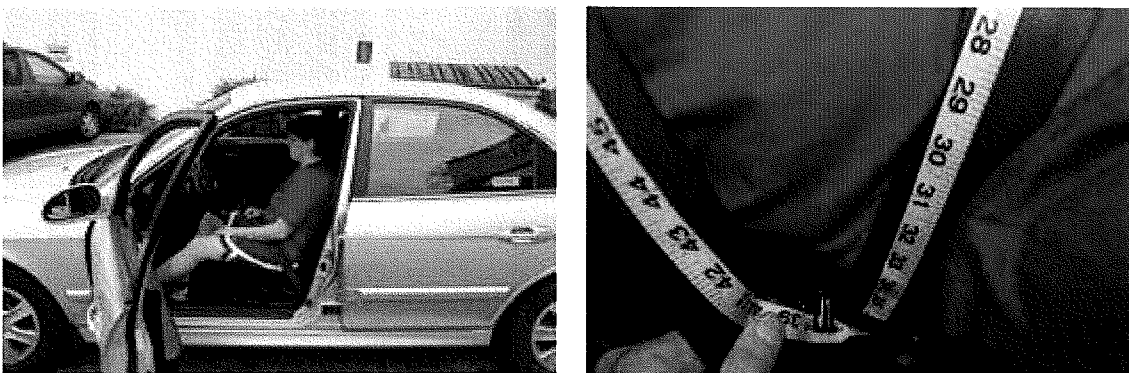
The length of the scuff marks and torn threads is likely attributable to the belt being dragged through the latch plate. When a surrogate of roughly the same size as Ms. Raley was placed into an exemplar vehicle, the surrogate's belt passed through the latch plate at approximately this location, see Figure 5.

Figure 5: Surrogate seated in an exemplar vehicle, belt passes through latch plate near 38".

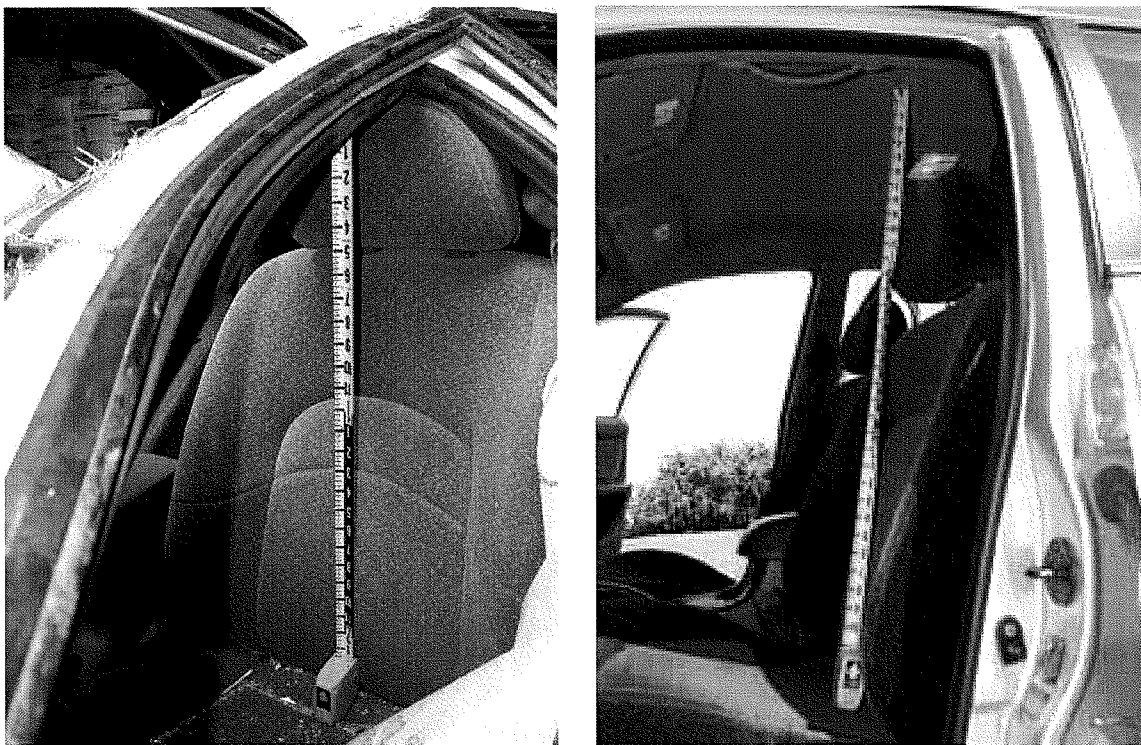
At the driver's seating location, there is approximately 28.25 inches of residual headroom, see Figure 6. An exemplar inspection indicates the original headroom was 38 inches.

At this position, the residual roof crush was 9.75 inches with an additional 20-30% dynamic crush during the rollover.

Figure 6: Driver's Headroom Comparison Between the Accident and an Exemplar Vehicle.

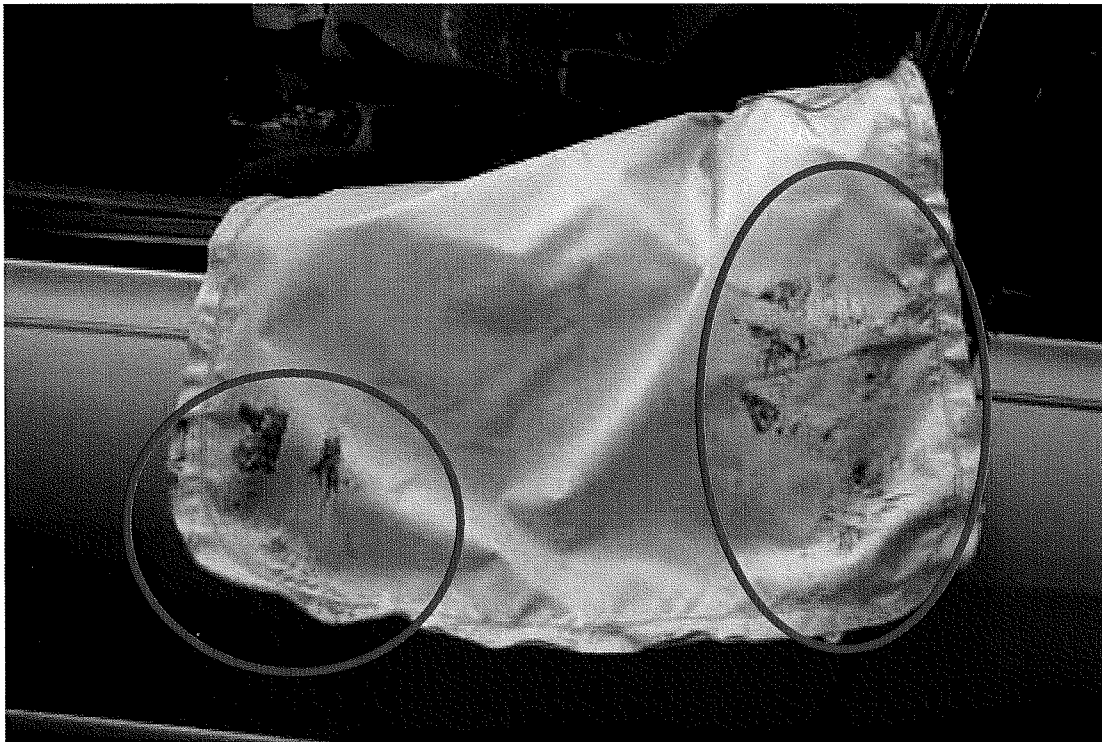
Blood is present on the inside surface of the deployed side impact airbag, which illustrates that Ms. Raley sustained injury inside the vehicle before being ejected, see Figure 7. Additionally, there is blood on the exterior surface of the driver side roof rail, see Figure 8. Ms. Raley most likely sustained injury inside the vehicle, at which point blood was transferred to the air bag, and she was subsequently ejected from the vehicle, at which time blood transferred to the roof rail.

Figure 7: Blood is present on the interior surface of the side impact airbag, indicating Ms. Raley sustained injury inside the vehicle before being ejected.

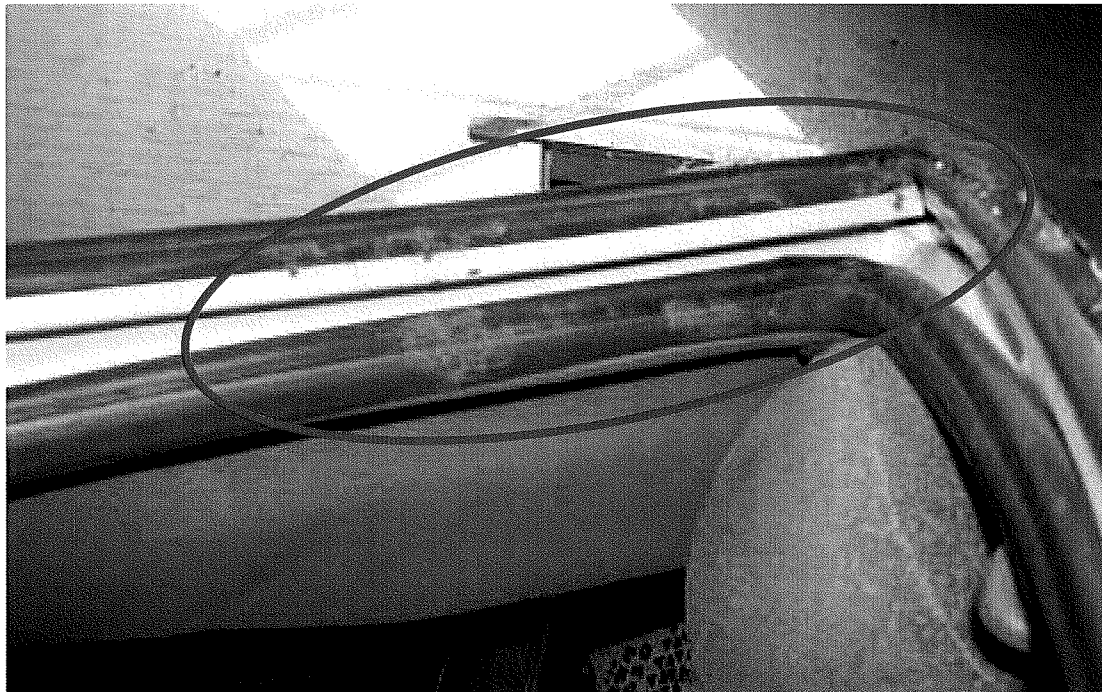
Figure 8: Blood on driver side roof rail, where it was transferred as Ms. Raley was ejected from the vehicle.

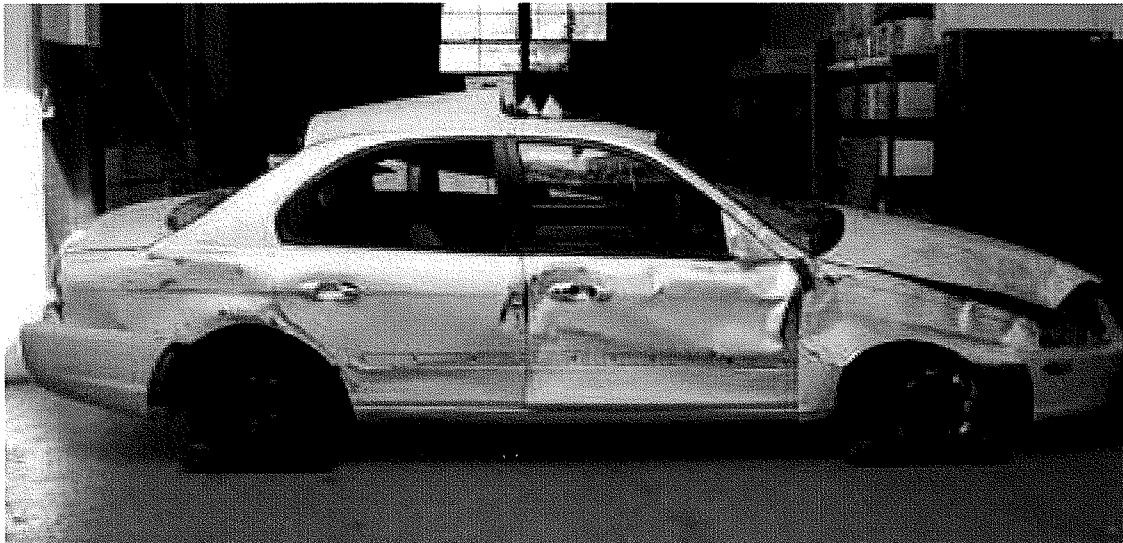
There is some light sideswipe damage along the passenger side of the vehicle from the contact with the sand barrels on the side of the road. This damage is depicted in Figure 9.

Figure 9: Sideswipe damage on passenger side of vehicle.

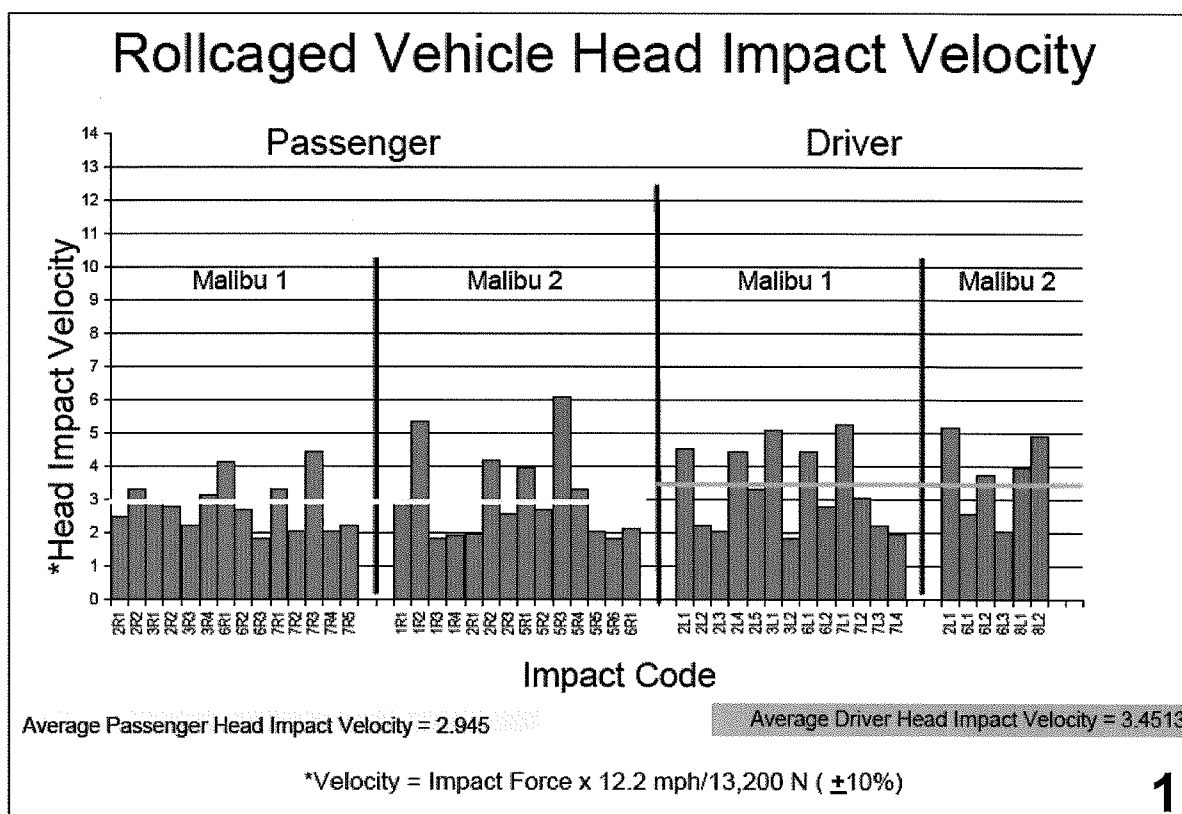
miles per hour and more probably in excess of 10 miles per hour. This range of speeds has been determined by many biomechanical researchers who have conducted tests with anthropometric dummies, whole cadavers and cadaveric specimens.^{4,5,6,7,8} The data collected from the Malibu studies conducted by General Motors, which are discussed in depth below, clearly demonstrate that even unrestrained occupants do not contact the roof with speeds much in excess of 3 miles per hour. The differential velocity required to produce a catastrophic neck injury like Misty Raley's comes from the defectively weak and rapidly intruding roof structure. Therefore, Misty Raley's restraint use status is entirely unrelated to the injuries she sustained in this rollover crash. Restrained and unrestrained occupants of rolling vehicles only suffer catastrophic neck injury when the roof crushes into the occupant compartment in the area that the occupant is located during the impact.

Figure 10: All impacts from Malibu rollcaged vehicles. The average head impact velocity for unrestrained dummies in Malibu I and restrained dummies in Malibu II was 2.9 mph for passengers

and 3.45 mph for drivers; well under the threshold for serious head or neck injury.

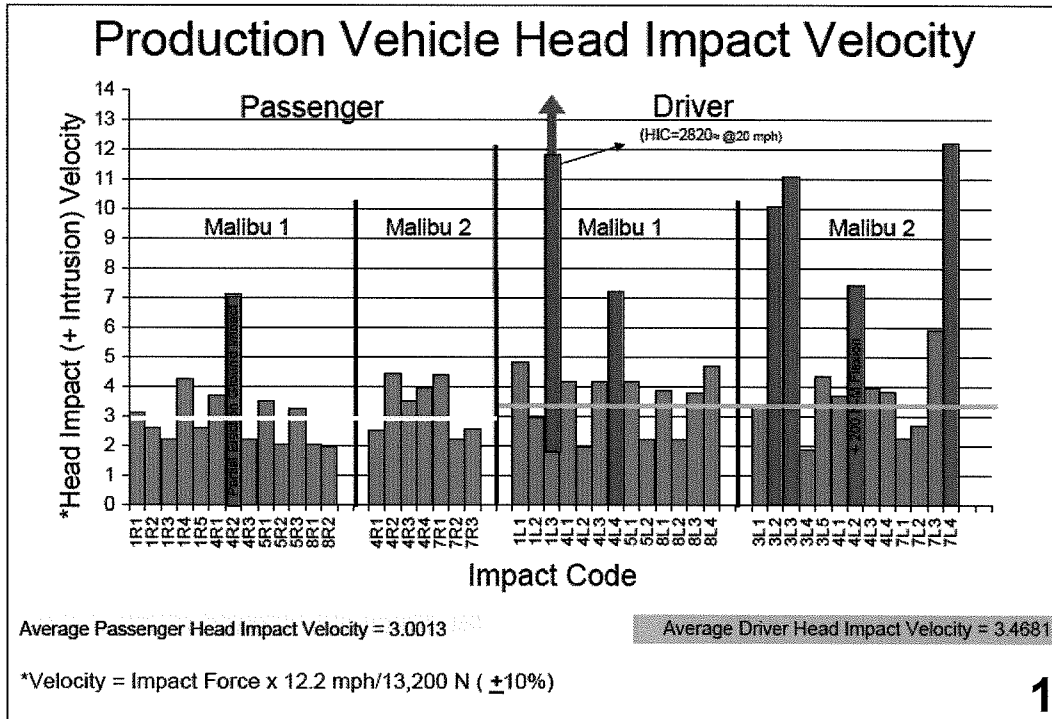
Figure 11: All impacts from Malibu production vehicles. The average head impact velocity for unrestrained dummies in Malibu I and restrained dummies in Malibu II was 3.0 mph for passengers and 3.46 mph for drivers; well under the threshold for serious head or neck injury – except in vehicles in which the roof catastrophically buckled and crushed into the occupant survival space. For these impacts the head impact velocity is in excess of 7 mph and, on four of the seven occasions, in excess of 10 mph.
